Maintenance Manual DG-400

1.3 Elevator deflections and adjustment

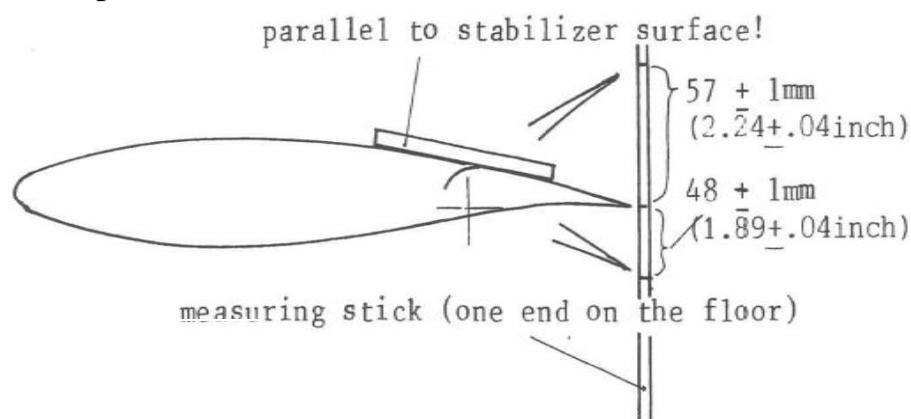
1.3.2 Elevator deflections and tolerances

Up 57 ± 1 mm ($2.24 \pm .04$ inch)

Down 48 ± 1 mm ($1.89 \pm .04$ inch)

measured 150 mm (5.9 inch) from. hinge axis.

The adjustment is made at the base of the control column. To measure displacement lay a straight edge over the elevator and trailing surface of the stabilizer (which is flat in this area). The straight edge must lie parallel to the stabilizer surface. Holding a measuring stick with one end on the floor mark the 0 point on the stick. Then mark the up and down displacements from this zero point.

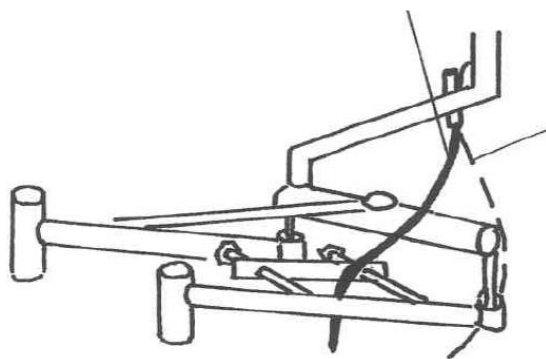
1.3.6 Repair of the automatic trim mechanism bowden cable

In the event of a replacement bowden cable being installed, it should be ensured that the cable passes between the two parallel arms of the control column mechanism as shown in the sketch.

Note: if the cable passes outside the mechanism control column movement could be blocked
