Maintenance Manual DG-600

1.2 Elevator control and trim system

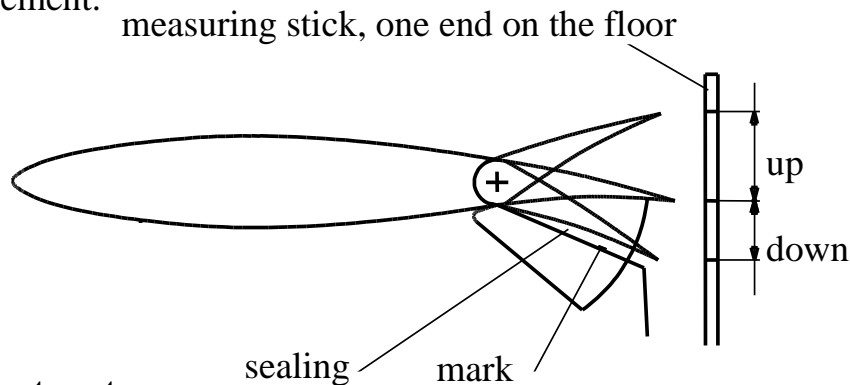
ser. no.'s	all except for 6-24		6-24 (with HT DG-800)	
	mm	in	mm	in
Up	61.5 \pm 1	2.42 \pm 0.04	46 \pm 2	1.81 \pm 0.08
Down	55 \pm 1	2.17 \pm 0.04	46 \pm 2	1.81 \pm 0.08
measured behind hinge axis at	160	6.3	134	5.3

Measurement:

Hold a measuring stick with one end on the floor. Deflect the elevator to neutral position by bringing the mark at the sealing in line with the upper end of the fin. Mark the 0-point on the stick. Then mark the up and down displacement.

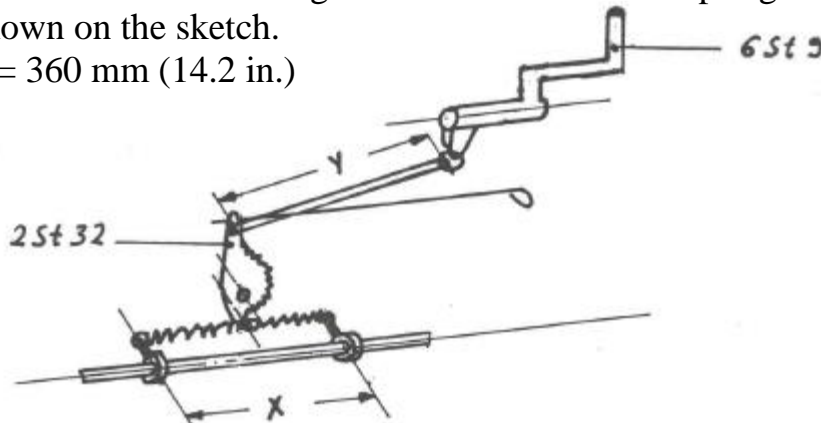
The automatic trim mechanism should be adjusted so that with full forward (nose down) trim the control column is in the maximum forward position. The tensioning of the trim mechanism springs is adjusted as shown on the sketch.

$x = 360 \text{ mm (14.2 in.)}$

The bungee interconnection between wing flap lever 6 St 9 and trim lever 2 St 32 is to be replaced, when worn or when elongated.

The length in unstretched condition y must be 110 mm (4.3 in.). The interconnection consists of 2 mm diam. bungee layer around 3 times.
