# Maintenance Manual DG-808C

### **1.2 Elevator control and trim system**

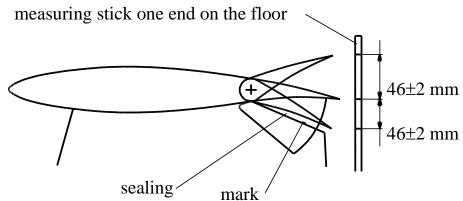
#### **1.2.2** Elevator deflections and tolerances

up:	46 <u>+</u> 2 mm	$1.81 \pm 0.08$ in.
down:	46 <u>+</u> 2 mm	1.81 <u>+</u> 0.08 in.

measured at 134 mm (5.3 in.) from hinge axis which is directly at the edge of the cut-out for the rudder.

Measurement:

Hold a measuring stick with one end on the floor. Deflect the elevator to neutral position by bringing the mark at the sealing in line with the upper end of the fin. Mark the 0-point on the stick. Then mark the up and down displacement.

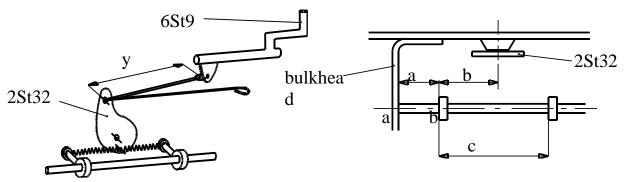
#### 1.2.5 Trim

The automatic trim mechanism should be adjusted according to the sketch below. The measurements a and b are with the control stick in forward position:

a = 30 mm (1.18 in.), b = 187 mm (7.36 in.), c = 357 mm (14.1 in.).

The bungee interconnection between wing flap lever 6St9 and trim lever 2St32 is to be replaced, when worn or when elongated. The length in unstretched condition y must be 110 mm (4.3 in.). The interconnection consists of 2 mm diameter. bungee wound around 3 times.
