- Subject** : PU fuel hoses, limitation of life-time, replacement by new types of fuel hoses
- Effectivity** type: DG-800  
variants: DG-808C
- Accomplishment** : Instructions 1, 2 and 6 up to 30 April 2018 but prior to the next annual inspection.  
Instructions 3, 4 and 5 when replacing the fuel hoses, latest when the fuel hoses have reached a service time of 6 years, respectively with the interim regulation latest end of 2018.

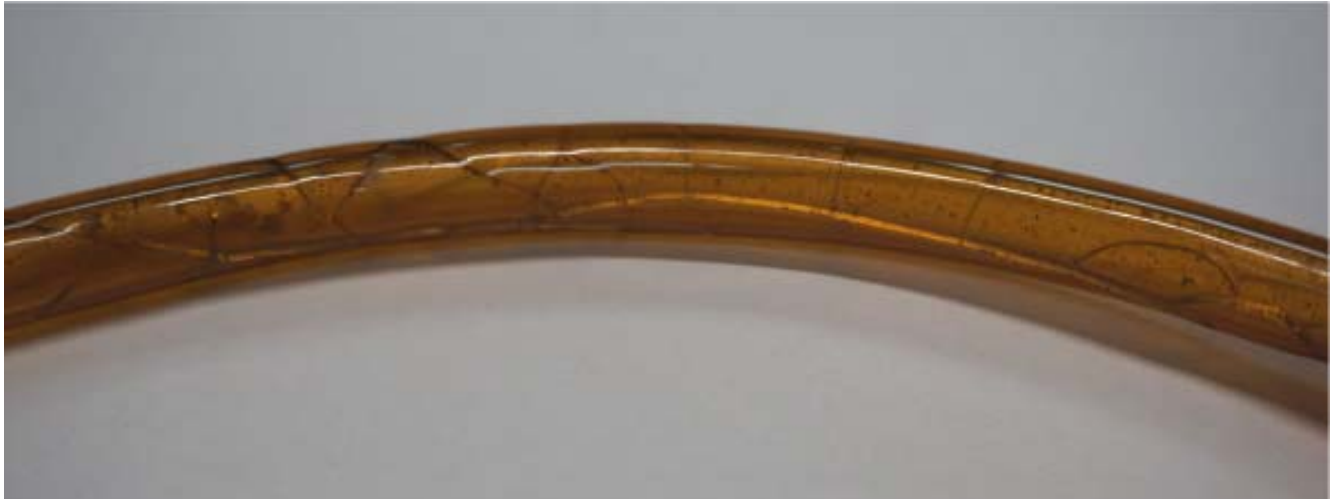
Photo for instruction 3

- Reason** : 1. The PU fuel hoses used so far in the DG-808C had no life-time limitation.  
During maintenance work on a 10 years old DG-808C a broken hose was found. In addition the look of the hoses had changed, see photo on page 3.  
Therefore the life-time of the PU fuel hoses will be limited to 6 years.

PU hose with crack lines starting at the inside of the hose

2. Interim regulation for fuel hoses having already a service-time of more than 6 years: Check the fuel hoses for damage and changed look see the photo on page 3. To enable the inspection you have to remove baggage compartment floors and rear wall.  
To check the hoses with metal shield it is sufficient to perform a random examination: Open the hose clamp at the connection of the fuel supply line (red) to the distributor 8M308/2 (see diagram 11 resp. 11d) and to slide the shield downwards by approx. 10 cm. To accomplish this you have to remove the red heat shrink tubing and may be one cable tie. After the inspection slide up the shield again, fix the hose clamp and replace the cable tie. It is not necessary to replace the heat shrink tubing. If a failure is found, all fuel hoses must be replaced immediately, otherwise the replacement must be done latest end of 2018.

3. Replace all fuel hoses in the fuselage by fuel hoses DIN 73379-2A and fire resistant fuel hoses ISO 7840-A1 in the engine area according to the issued with this TN:
