Gegenstand : Zylinderfußdichtung  
Subject : Cylinder-base-gasket

Betroffen/Applicability : Motoren/engine Solo 2625 eingebaut/installed in:  
Typ/type: DG-500, DG-800  
Baureihen/variants DG-800B, DG-808C, DG-500MB

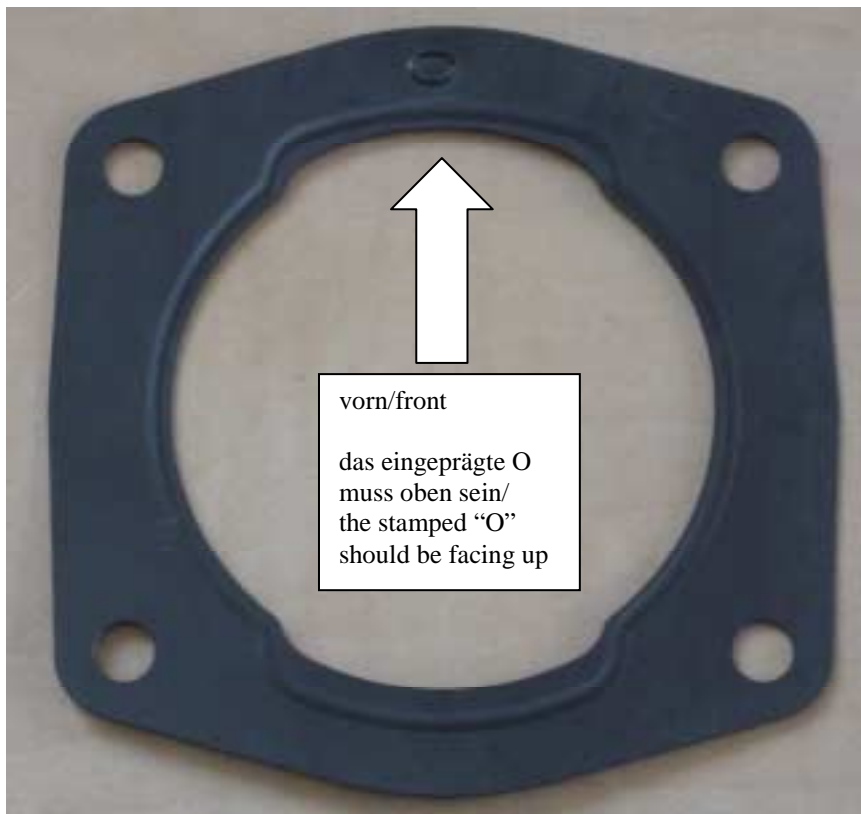
Photo 1

Vorgang : Die Fa. Solo hat neue verbesserte Zylinderfußdichtungen entwickelt.  
Reason : The Solo company has developed new improved cylinder- base -gaskets.

Massnahmen : 1. Ev. vorhandene Dichtungen, die nicht dem Foto 1 entsprechen, dürfen  
Instructions : nicht verwendet werden.  
2. Prüfen, ob die Zylinderfußschrauben gemäß Foto2 (eingeschnürt)  
ausgeführt sind. Ansonsten auch die Zylinderfußschrauben austauschen.  
1. Don't use cylinder- base -gaskets which you may have on stock other  
than shown in picture 1 below.  
2. Check if the cylinder base studs are of newer necked down design, see  
photo 2. If not, replace the studs by the latest design

Material: DG Bestellnr./DG part no.:  
60500232 Zylinderfußdichtung /cylinder- base -gaskets  
60500180 Dehnschraube Zylinderfuß / necked down cylinder base stud
